Section 319

NONPOINT SOURCE PROGRAM SUCCESS STORY

Oregon

Stakeholders Collaborate to Reduce Bacteria Levels

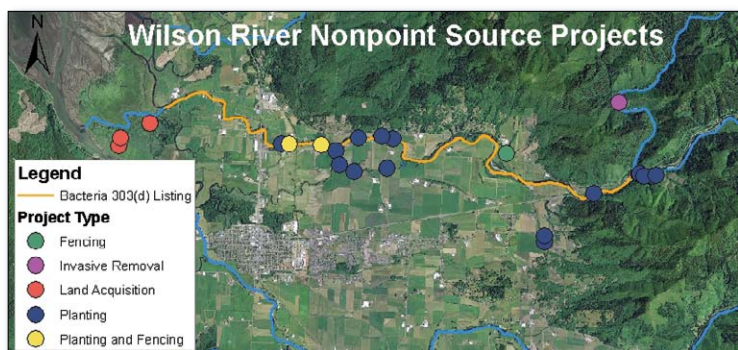
Figure 2. Stakeholders completed numerous restoration projects in the lower Wilson River watershed.

Between 2002 and 2007 stakeholders implemented numerous BMPs in the lower Wilson River watershed (Figure 2). The TBWC, TEP and Tillamook SWCD worked with landowners to complete 20 riparian enhancement projects (12 of which were BYPP projects) that included planting, fencing and invasive species removal. The projects stabilized streambanks and removed livestock from the river's riparian area. In addition, TEP acquired three sensitive wetland parcels, which will be restored in the coming years and maintained by Tillamook County as permanent wetland areas.

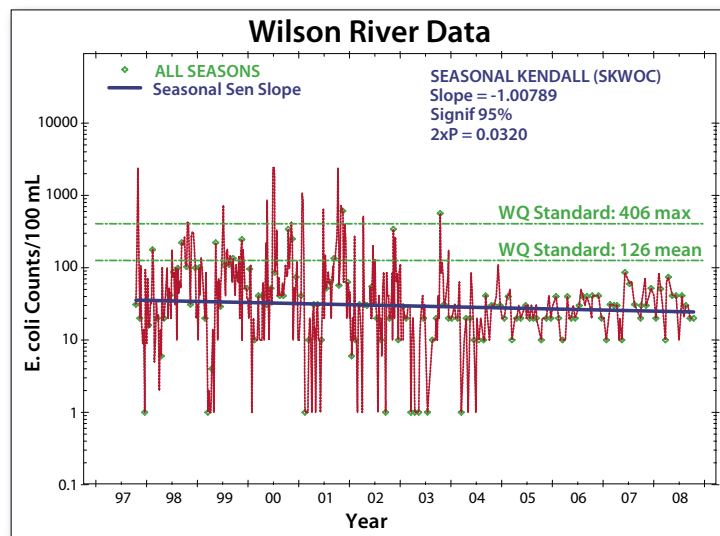
Figure 3. Bacteria levels in the Wilson River have steadily declined since 1997 and now consistently meet the two-part recreational use water quality standard, which requires (1) that the 30-day log mean not exceed 126 *E. Coli* counts per 100 mL from a minimum of five samples and (2) that no single sample exceed 406 *E. Coli* counts per 100 mL.

Stakeholders' efforts to target and reduce bacteria pollution throughout the Tillamook Bay watershed appear to be working. Data show that bacteria levels in the Wilson River have met water quality standards since 2005 (Figure 3). The lower sections of
